Delivery Order 9 Enhanced Preliminary Assessment

FORT DEVENS, MASSACHUSETTS

April 1992

ENHANCED PRELIMINARY ASSESSMENT

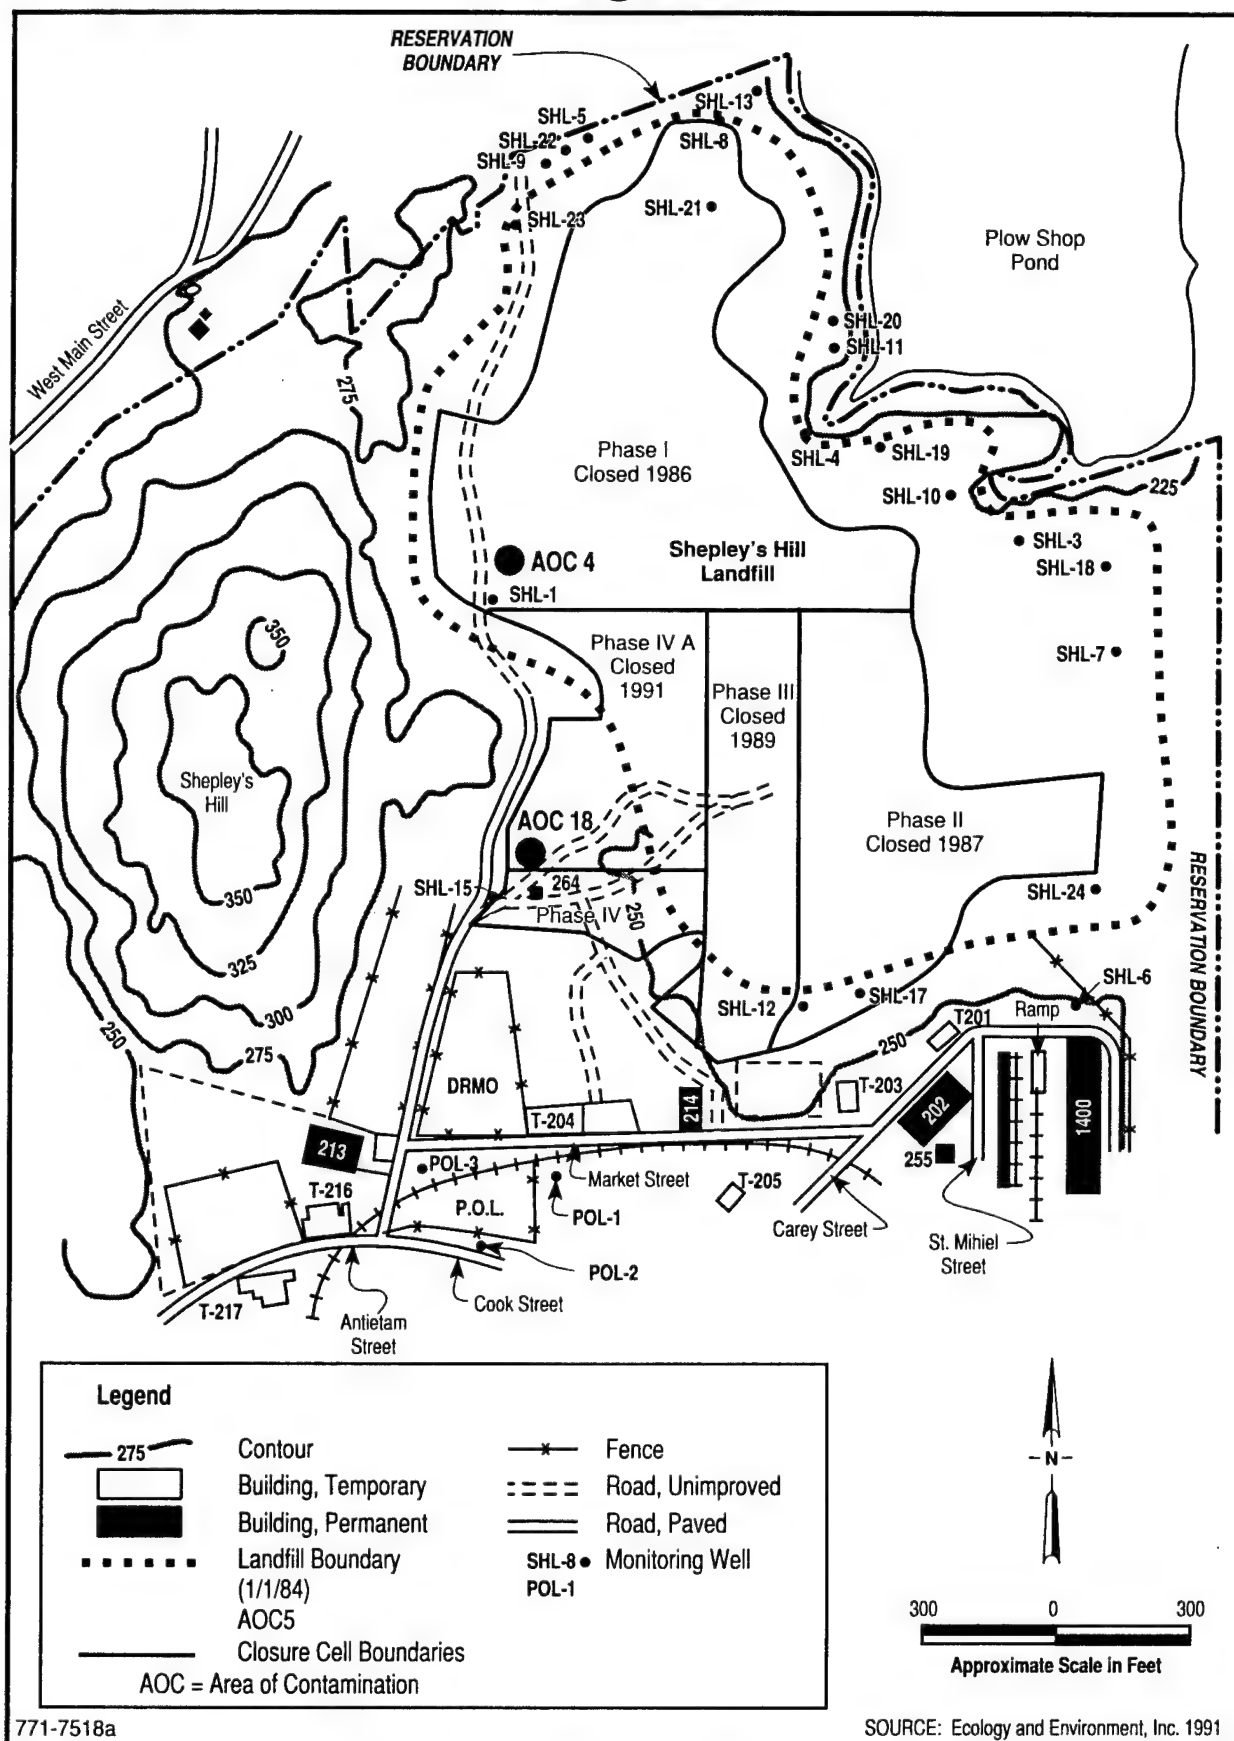
**FIGURE 3-2 LOCATION OF SHEPLEY'S HILL
LANDFILL (NO.1) INCLUDING FORMER
SANITARY LANDFILL INCINERATOR
AND THE ASBESTOS CELL**

The landfill is operated using the modified trench method. There is evidence that more recent trenches in the northwest portion may have cut into previously used areas containing glass and spent shell casings. The glass dated from the mid-nineteenth century to as late as 1920. The total depth of the refuse is about 30 ft (DEH, 1985b).

Fort Devens has an operating permit from the MDEP, and according to available information, the landfill is operating within these requirements. In an effort to abate the potential for off-site contaminant migration, Fort Devens initiated the Fort Devens Sanitary Landfill Closure Plan in 1984, in accordance with 310 CMR 19.00. The four-stage plan, written by Gale Engineering, was submitted to MDEP for review and approval. As part of a corrective action, the last section of the landfill was scheduled for closure in 1991 and an extension may allow operation into 1992; most of the landfill has already been closed (Figure 3-2). Fort Devens is coordinating the closure with MDEP authorities and is following an approved closure plan that includes regrading, gas ventilation, membrane capping, and a final vegetative cover. Some of the areas adjacent to Plow Shop Pond lie within the 100-year floodplain (Gale Engineering, 1985).

The landfill site was probably selected because it was a wetland area and was an expedient choice for direct disposal of wastes. Information indicates that it was formerly operated as an open burning site. At a later time, waste was incinerated and the residue was buried. Con-Test (1989) reports that during a 1984 investigation, 40 test pits were excavated in various locations. An area of special concern was a location in the southeastern portion of the landfill reportedly used to dispose of flammable fluids. The report cited by Con-Test indicates that contamination was not substantiated by test pits or other research.

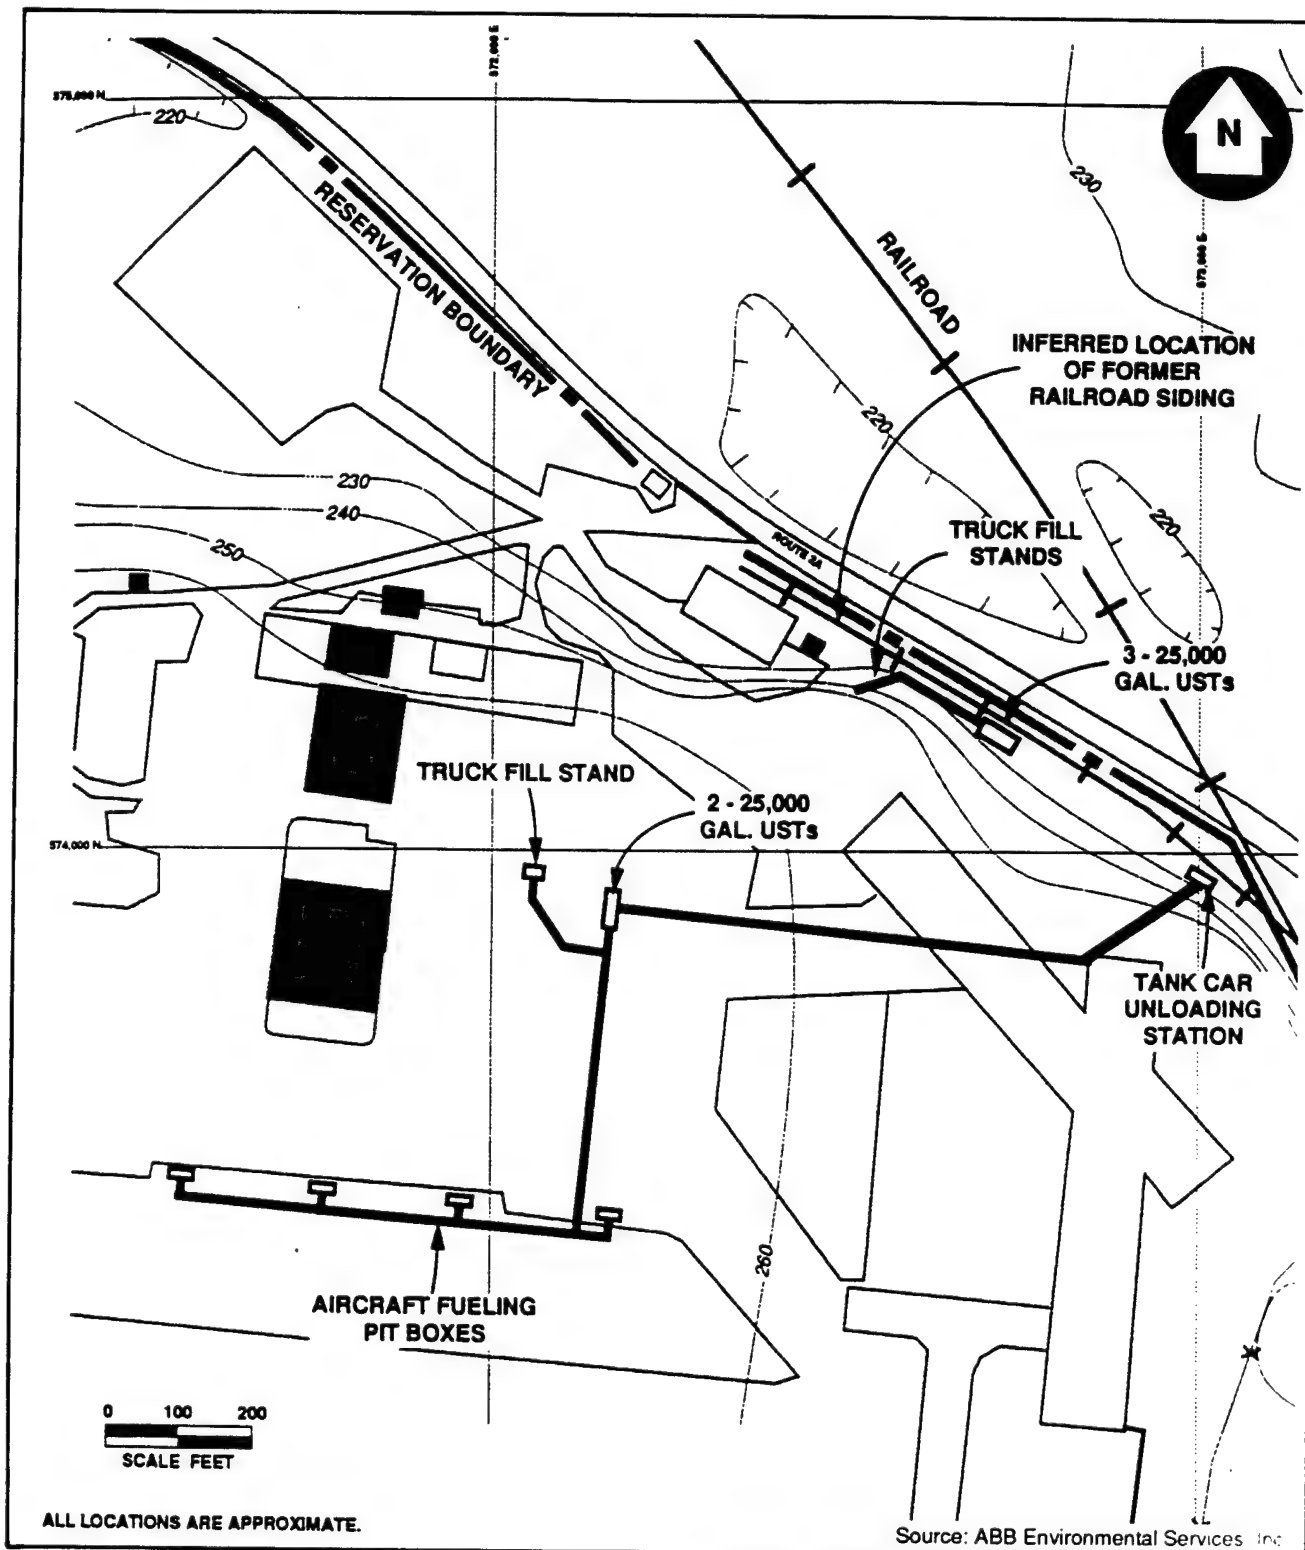
FIGURE 3-5 APPROXIMATE LOCATION OF FEATURES ASSOCIATED WITH WWII FUEL POINTS (AREE 50)

The site consists of two sets of aircraft fuel tanks, a network of piping, fuel points, and truck fill stands. One set of three 25,000-gal gas fuel USTs is located east of Building 3803. Three tanks are shown on Fort Devens Drawing No. X100-109/43A, date August 1942, along with a water separator pit and piping to two truck fill stands. Another set of two 25,000-gal gas storage USTs is located east of Building 3818. The two tanks are shown on Fort Devens Drawing No. 6101-243 dated February 1941, along with piping leading to two separate locations, one of which is the four aircraft fuel points. Figure 3-5 shows the approximate locations of features associated with AREE 50. Abandoned tanks will be removed under the installation UST removal program with close coordination with MDEP and EPA.

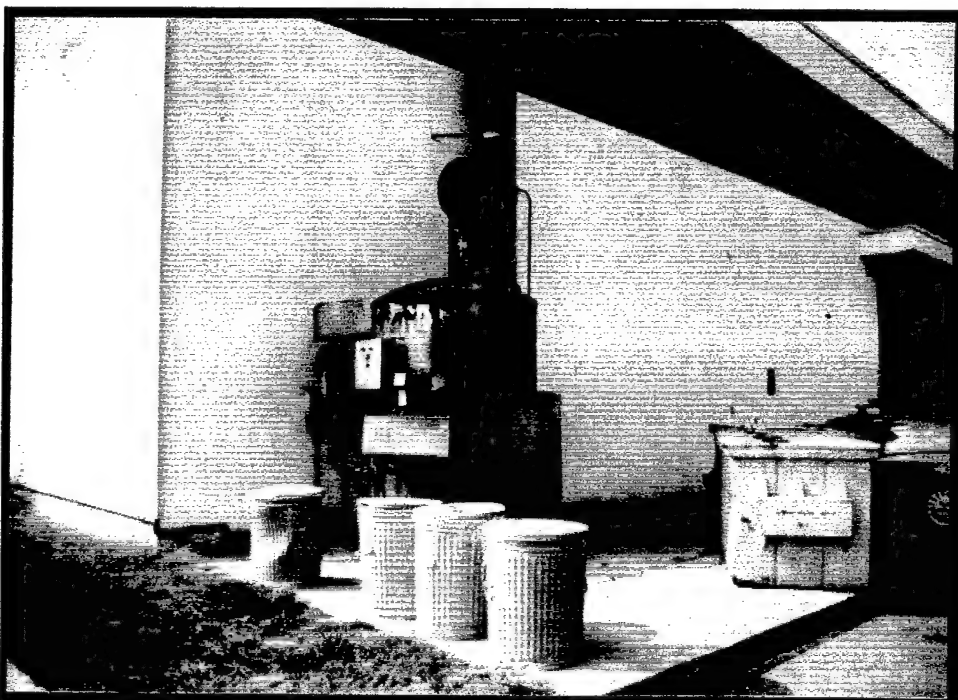
1. AREE 1 - CUTLER ARMY HOSPITAL INCINERATOR

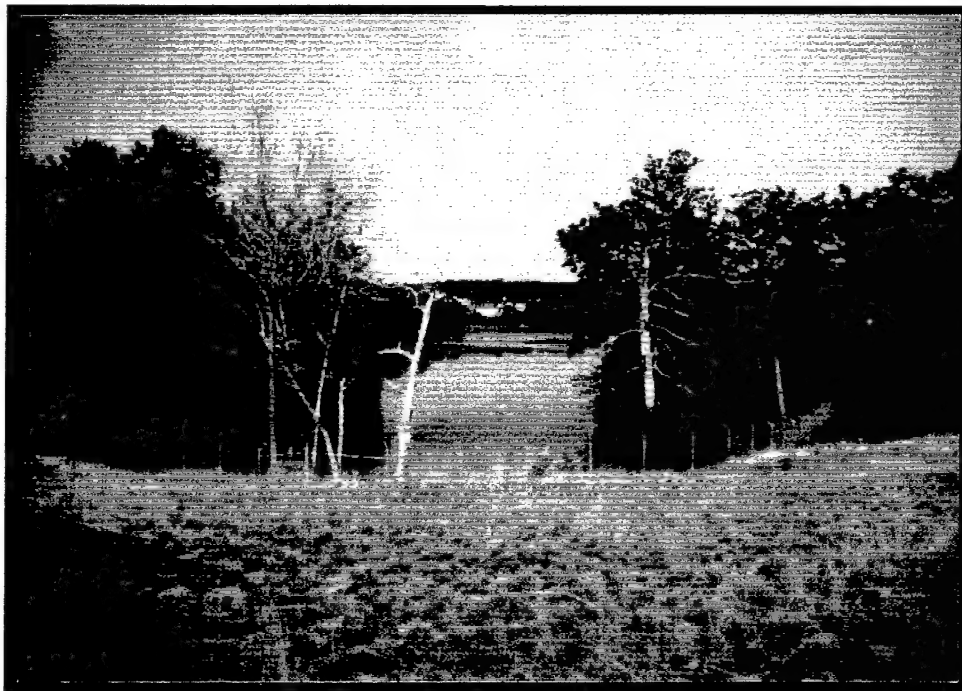
**2. AREE 5 - SHEPLEY'S HILL LANDFILL (NO.1) (FOREGROUND) AND
LEACHATE DISCHARGE POINT IN PLOW SHOP POND (BACKGROUND)**

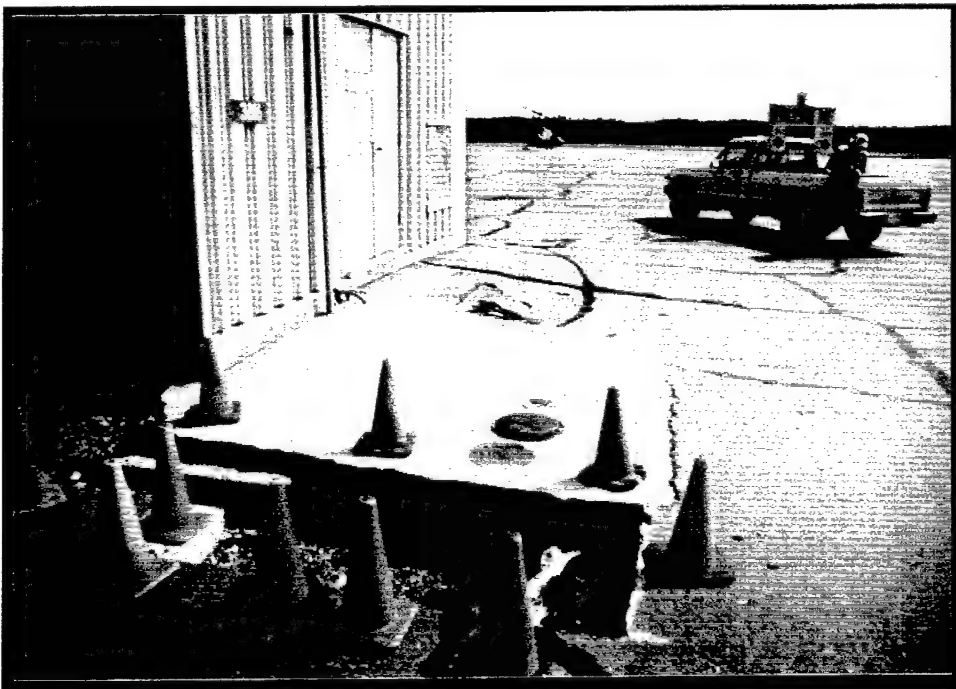
19. AREE 47 - FORMER LUST SITE AT MAAF (BUILDING 3816)

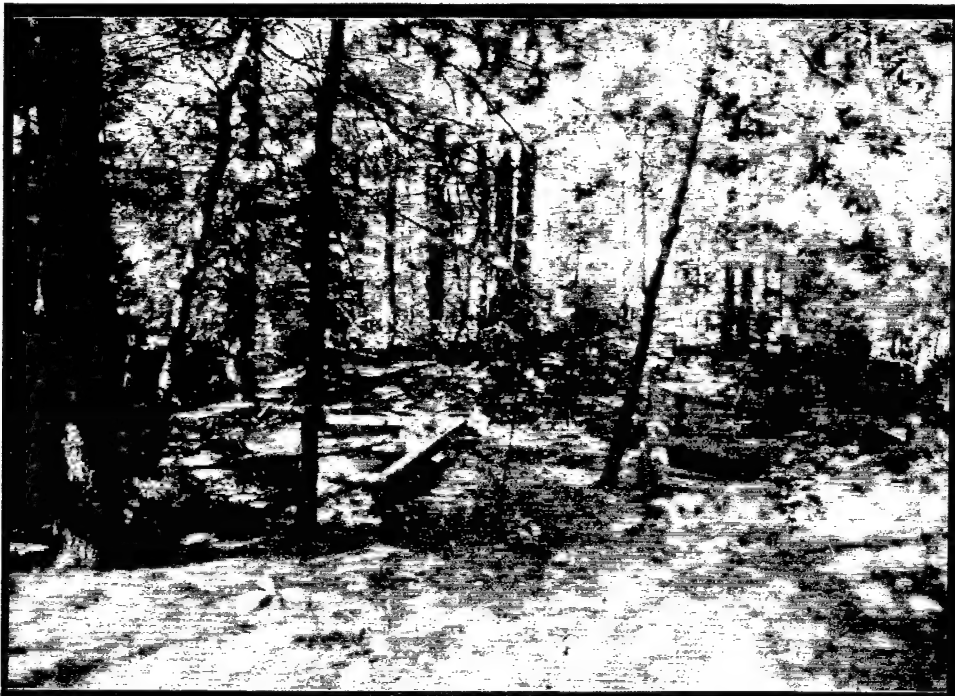
20. AREE 50 - WWII ERA LUST SITE NEAR MAAF
